Crack Formation during Electrodeposition and Post-deposition Aging of Thin Film Coatings

3rd Quarterly Report
July-September 2016
AESF Research Project #R-118

by
Prof. Stanko R. Brankovic
University of Houston
Houston, Texas, USA

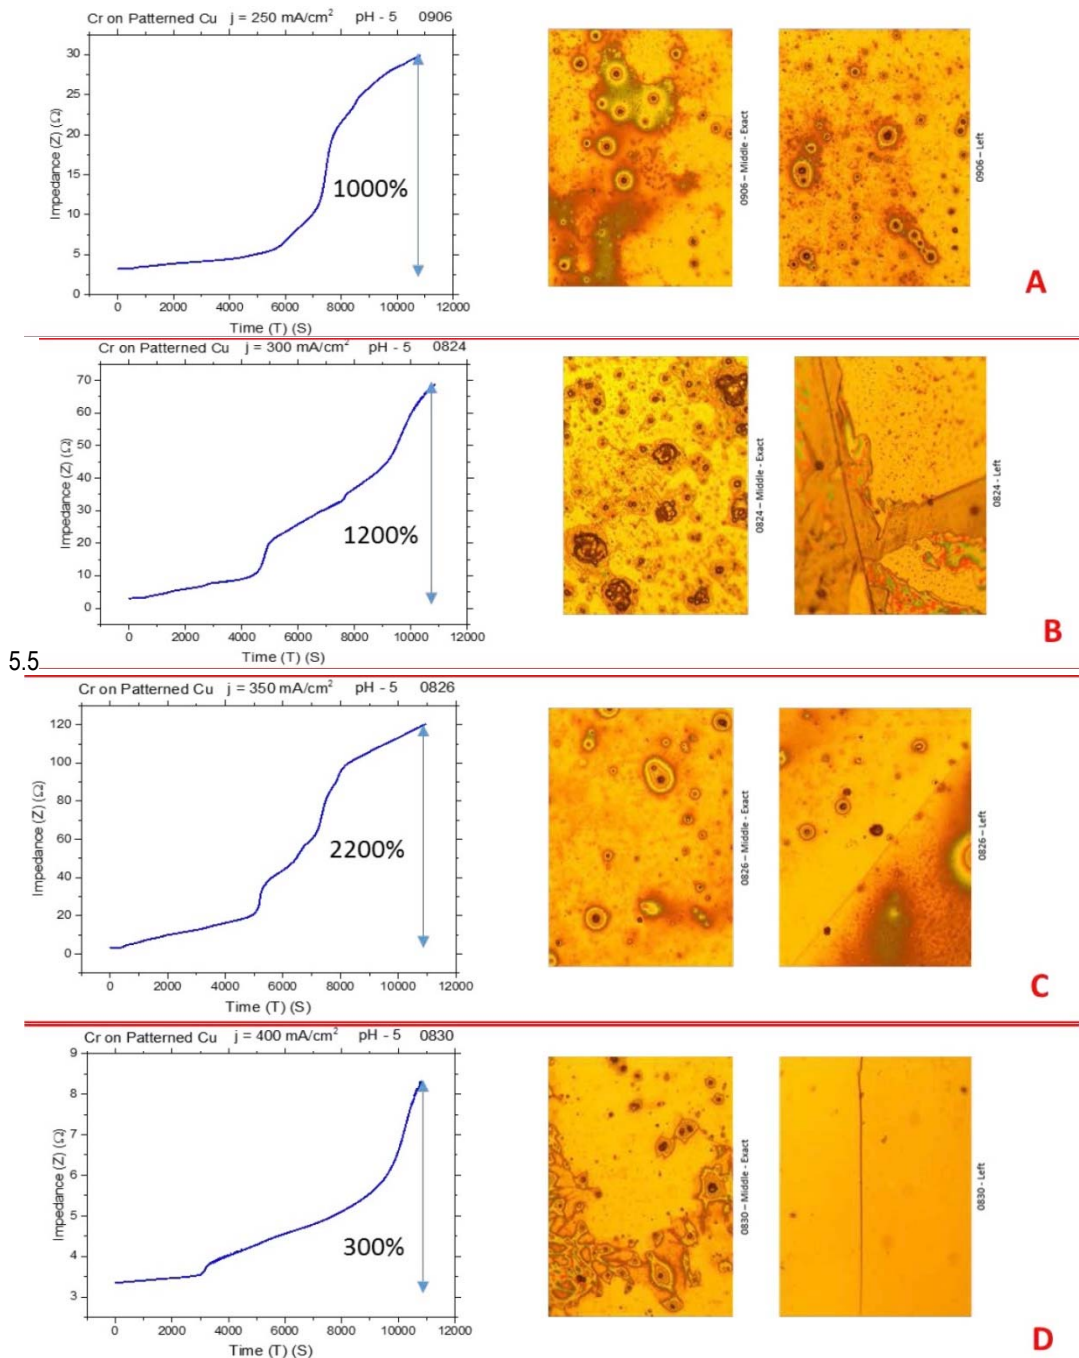
The observed resistance changes for chromium films deposited with different current densities are shown in Fig. 1(a-d), over pages 16 and 17. The optical images of the representative morphology of the chromium surface for each sample are also shown on the right side for each transient. Impedance transients were recorded over the time intervals of 3 hr, while the approximate chromium film thickness was around 15 microns. The maximum change in the impedance value is indicated in the graph.

Figure 1 - *In situ* impedance measurements of chromium films during aging at room temperature in air: chromium films deposited for ~3 hr at (a) 250 mA/cm^2 , (b) 300 mA/cm^2 , (c) 350 mA/cm^2 and (d) 400 mA/cm^2 . Optical images are taken from the center and very near edge of the sample; AC amplitude 3 mV, frequency 50 kHz.

The common feature of all results in Fig. 1 is the quite significant magnitude of the impedance change. It ranges from 300% to 2200%. There is no obvious trend and correlation of the impedance change with respect to the conditions of the electrodeposition process and deposition current density. Initially, (Fig. 1(a-c), Fig. 2) we see the increasing impedance change

with increasing current density, ($j = 250\text{--}350\text{ mA/cm}^2$) and then, a significant decrease in relative change of impedance with further increase of current density, Fig. 1(d), and Fig. 2.

The optical inspection of the chromium samples as well as the smooth appearance of the impedance transients do indicate that no crack formation in the chromium deposited films occurs at room temperature as a result of the aging process. This is a bit surprising considering the large values of impedance change that are observed. Indirectly the data suggests that the source of such a huge change of the impedance of chromium films must be related to the increased volume concentration of the defects in the chromium films.

change indicating no crack formation. This result is in perfect agreement with the qualitative shape of the *in situ* impedance curves shown in Fig. 1. Therefore, both *in situ* measurements, impedance and stress, suggest that there is no crack formation during room temperature aging of chromium films in air. This conclusion is the same as the one from our previous report where aging of chromium films in solution was studied.

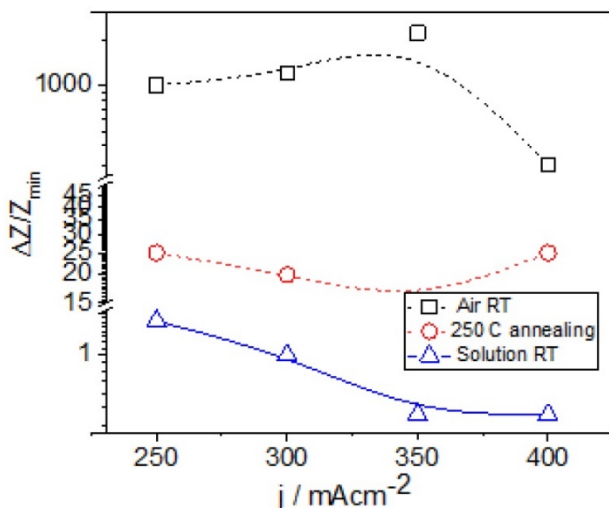
Figure 2 - Relative change of the impedance of $\sim 15 \mu\text{m}$ chromium films during the aging process in Cr-formate solution and in air at different temperatures. Black - room temperature data from Fig. 1 (copper seed); Blue - room temperature data recorded during aging in solution (copper seed, 2nd quarterly report, R-118-Q2); Red - 250°C data from Fig. 5, NiCr seed.

The important thing to notice here is a different magnitude of the impedance change for two different aging processes at room temperature. In the case of the aging of chromium films in Cr-formate solution, the change of the impedance was of the order of 1% (Fig. 2). The aging process in air, at the same temperature results in almost three orders of magnitude larger impedance change. The observed trends with respect to the current density used for sample preparation also diverge. In reality, the aging in air is the more relevant process to consider since it is to happen no matter what

The observed trend in relative impedance change as a function of the current density used for chromium deposition is quite different than the one obtained from room temperature measurements, Fig. 2. It is almost the opposite of the one observed for samples aged in air and, surprisingly, more similar to the one for samples aged in solution. The relative change of the impedance is about an order of magnitude larger than that from the samples aged in solution, and about two orders of magnitude lower than the one from the samples aged in air, Fig. 2. To some extent this is unexpected as one would anticipate that cracking of the chromium films should result in a very large increase of the chromium thin film impedance.

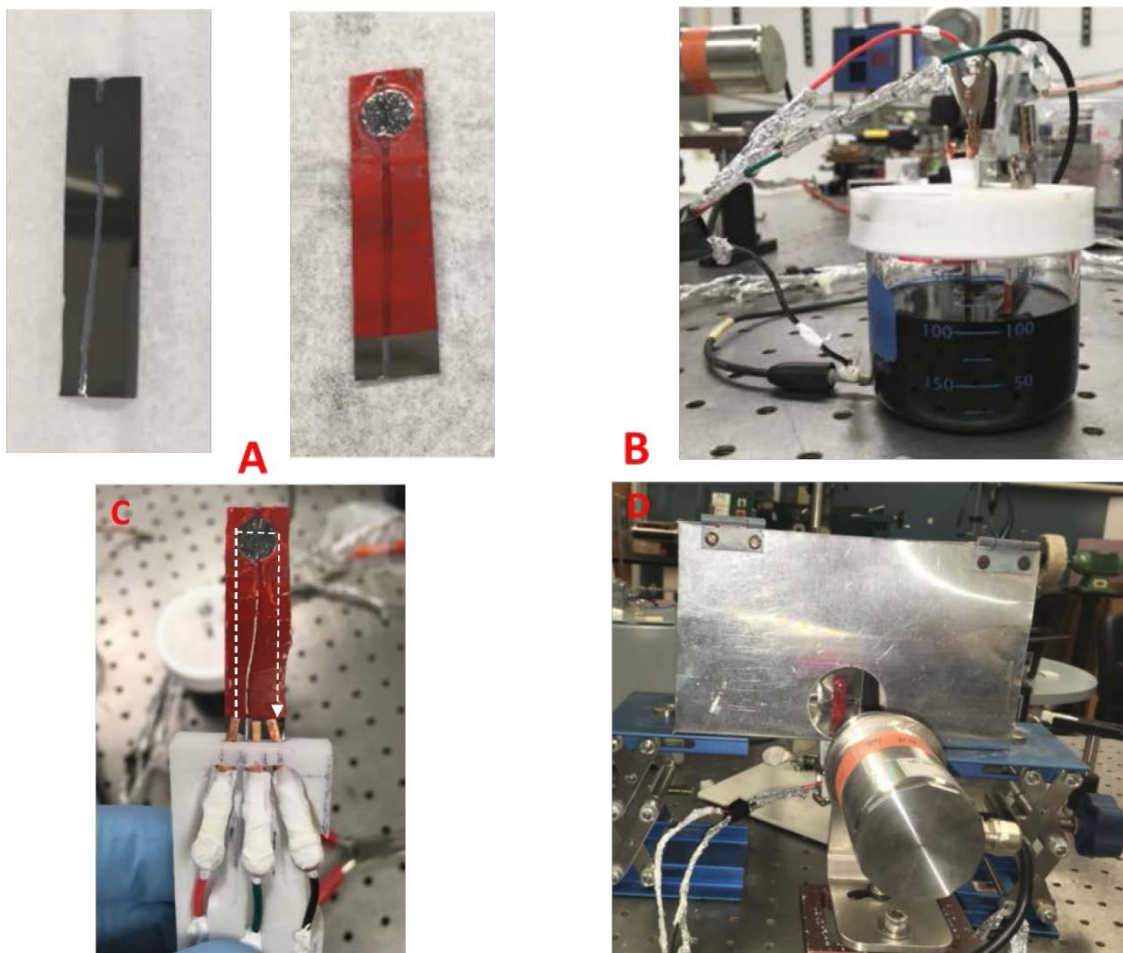
For the purpose of these measurements, we have designed a special set up where the chromium films can be controllably heated at a desired temperature and, at the same time, their impedance can be measured *in situ*. The initial sample geometry and preparation was the same as described in previous report (2nd quarterly report, R-118-Q2) for room temperature *in situ* measurements (in solution and air). The samples with NiCr seeds (100 nm) on SiO_2 substrates were prepared in such a way that the conduction path in the sample was designed to go through the electrodeposited chromium film, Fig. 3(a-c). The electrodeposition set up, as in the previous measurements, was designed to match the electrode areas and separation used in

the cell for *in situ* stress measurements, Fig. 3c. Each sample was electrodeposited just prior to the measurement to reach the thickness of ~15 microns. The chromium films were heated using a tandem of two IR heaters positioned at the back of the film, while the temperature of the film surface was measured by an IR-sensor positioned on the front side, Fig. 3d. The chromium film-fixture and the heaters were enclosed in a radiation-reflective box to minimize the heat losses to the environment. The film surface was optically accessible through the opening in the enclosure from the front side to the laser targeting mechanism of the IR sensor's optics. This allowed precise positioning of the area/spot of the chromium film from which temperature was measured, Fig. 3(c-d). The representative temperature transient during chromium thin film annealing is shown in Fig. 4. One can see that the 250°C temperature is reached within the first 150-200 sec, and for the rest of the annealing time (3 hr), it was kept constant.

Figure 3 - The setup for *in situ* chromium thin film impedance measurements during the annealing process: (a) sample with patterned NiCr seed and sample with electrodeposited chromium film; (b) cell for electrodeposition; (c) sample holder during annealing with electrical connections. The current path is indicated with a white dotted line; (d) set-up for annealing displaying enclosure, sample, laser spot targeting sampling place for temperature measurement and IR sensor.

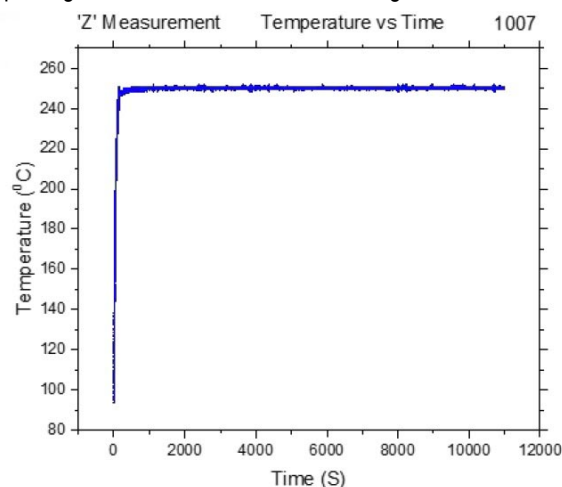
Figure 4 - Representative temperature transient during chromium thin film annealing.

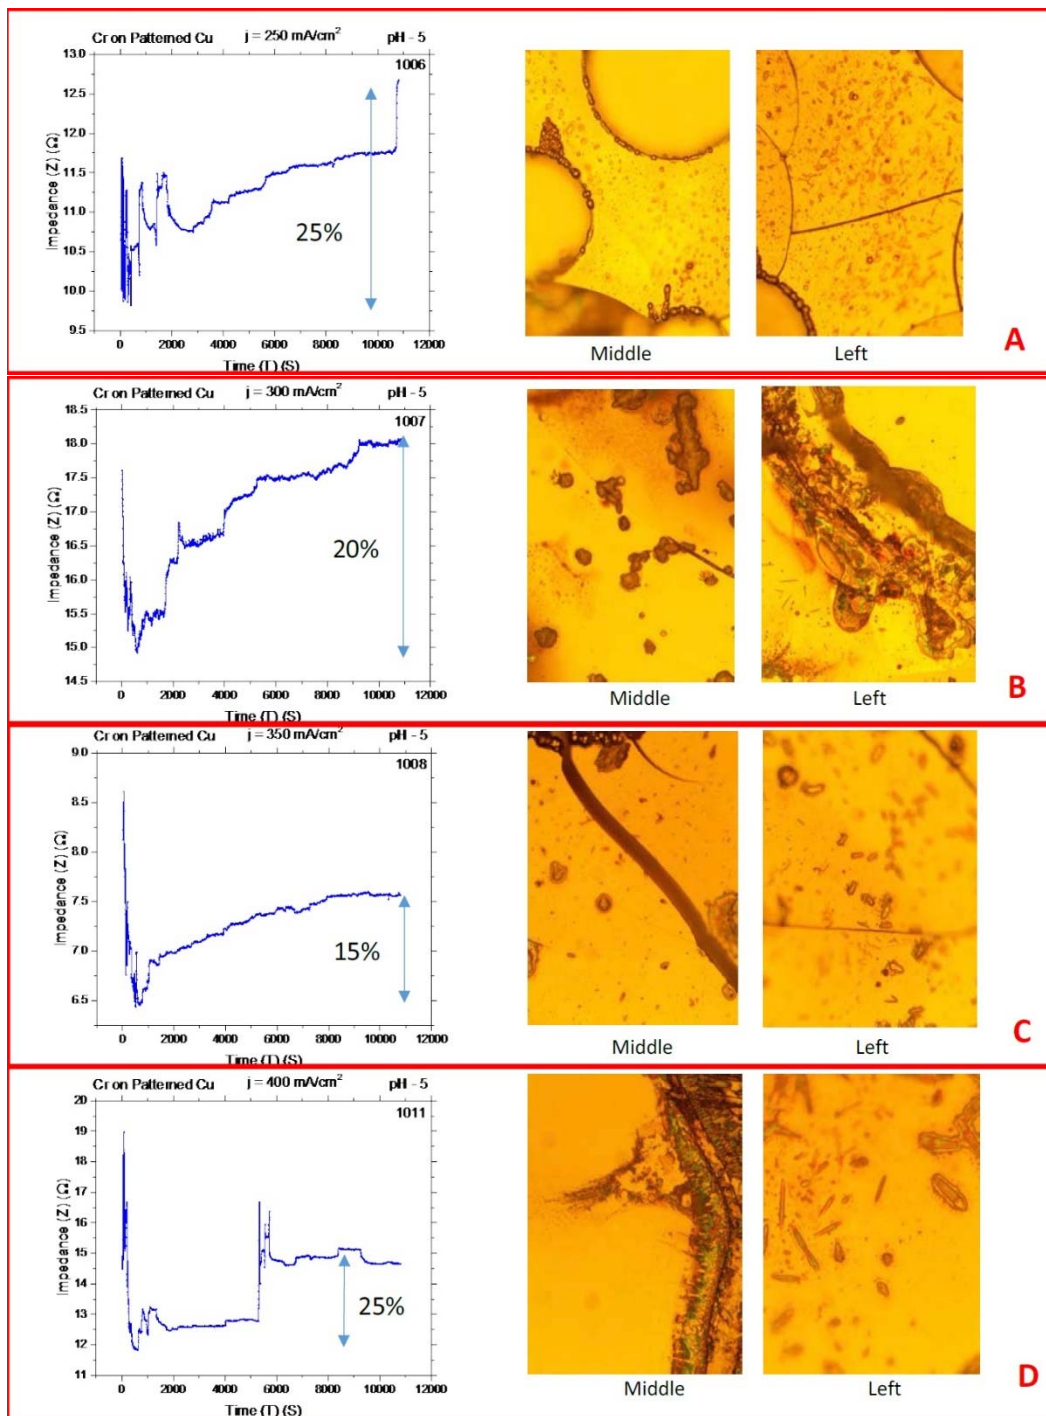
The results from the *in situ* impedance measurements are shown in Fig. 5(a-d), over pages 20 and 21. In all samples tested, the common feature of the impedance transients is a sharp decrease in the initial impedance value as the temperature is raised to 250°C, and then an increasing trend with the progression of the annealing run. All transients exhibit a sharp spikes and discontinuities which are the signature of crack formation in the chromium film. The relative change in the impedance value during the course of experiment is indicated in each transient. The representative optical images of the chromium surface are shown on the right side of the corresponding sample/transient. In some of the images, the presence of cracks is evident, although not of very high density. The films do show a slightly different surface morphology than the ones obtained during room

Figure 5 - *In situ* impedance measurements of chromium films during aging at 250°C in air. The chromium films were deposited for 3 hr at current densities of (a) 250 mA/cm², (b) 300 mA/cm², (c) 350 mA/cm² and (d) 400 mA/cm². Optical images are taken from the center and very near edge of the sample. AC amplitude = 3 mV, frequency = 50 kHz.

temperature aging, Fig. 5 vs. Fig. 1. At this point however, a more quantitative analysis of the difference is not possible based on the optical images we have acquired.

A closer examination of the impedance transients from Fig. 5 shows that the frequency of abrupt interrupts of the transients, *i.e.*, chromium film cracking, is the largest for the samples deposited at 250 mA/cm² and 400 mA/cm² (Fig. 4a,d). The same samples do show the largest overall change in impedance. This is expected as the cracks formed do represent an ultimate obstacle for current flow. Therefore, within this experiment, the transient qualitative appearance is in agreement with the overall impedance change during annealing. The optical images of the 250 mA/cm² sample show clear evidence of crack formation while this is not obvious in the case of 400 mA/cm² sample.

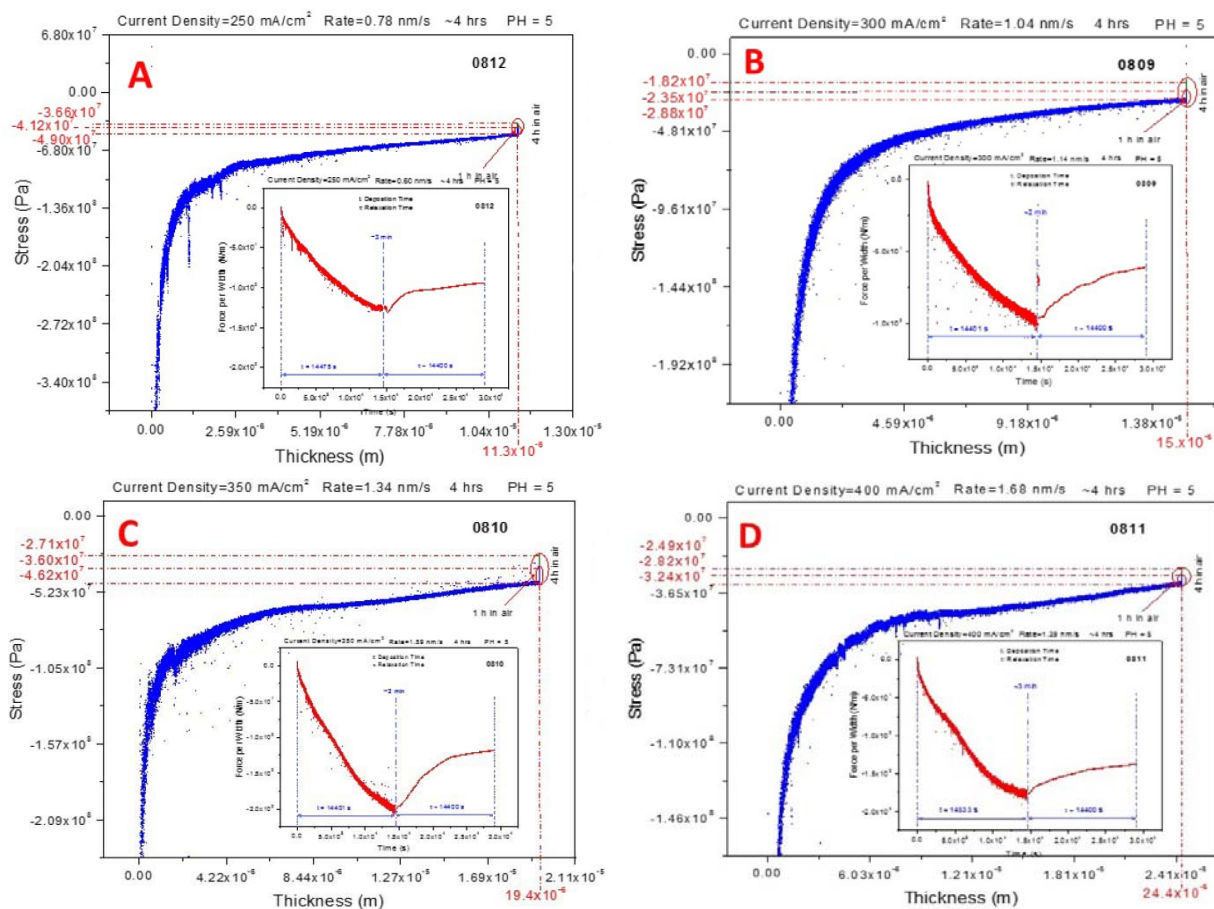
Figure 6 shows the stress-thickness and stress-time curves for *in situ* measurements during deposition (250-400 mA/cm²) and subsequent aging of chromium films in air.

Figure 6 - *In situ* stress measurements during deposition (blue - transients, stress vs. thickness) of chromium films and during aging in air (red - transients, stress vs. time): (a) 250 mA/cm², (b) 300 mA/cm² (c) 350 mA/cm² and (d) 400 mA/cm².

The three-second interruption between the deposition and aging steps of the measurements is related to the solution dispensing. The blue curves represent the stress-thickness dependence and the red curves are stress transients. The common feature of all of the measurements is that, as in the previous report, the deposition stress of the chromium films is compressive, entering a steady state mode after approximately 1.5 hr of deposition, Fig. 6(a-d).

The aging stress relaxation is tensile for each sample entering the steady state after approximately 2 hr. This behavior is very similar to what we have reported previously for the stress evolution studies of chromium films during aging in solution. The tensile stress relaxation as a function of current density used for chromium deposition has a weak decreasing trend. The magnitude of tensile stress relaxation is on the order of several tens of MPa, which is a relatively low change of stress at the end of deposition step, Fig. 6(a-d). The stress transients (red lines in Fig. 6) during deposition and aging do not show any abrupt

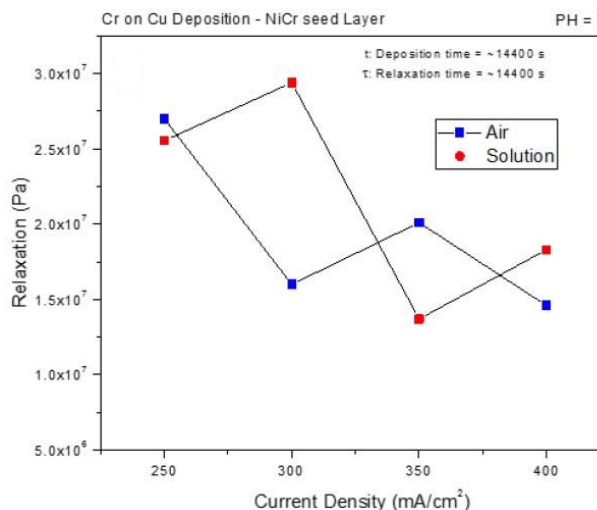
Comparison between stress relaxation data for chromium films aging in air and for chromium films aging in formate solution is shown in Fig. 7. Both sets of experiments yield qualitatively the same trend and the same magnitude of the stress change. To some extent this is expected, knowing that relatively more Cr-hydride per deposited chromium atom should be formed at a lower current density where the current efficiency is lower (see previous report). Assuming that Cr-hydride decomposition is the main mechanism leading to the tensile stress relaxation, we expect larger tensile relaxation for the samples deposited at lower current densities. Therefore, the agreement between stress relaxation data in these two sets of experiments shown in Fig. 7 is not surprising.

Figure 7 - The maximum tensile relaxation of chromium films during a three-hour aging in solution (red - previous report) and air (blue - data from Fig. 6).

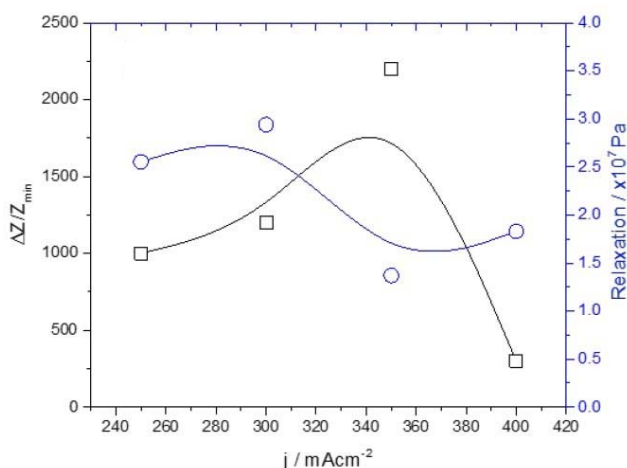
There are two important differences between the data presented in this and the previous report. First, the tensile stress relaxation and change in impedance do not follow the same trend as a function of current density. They completely diverge, shown in Fig. 8. This is significantly different from what we have observed during the aging of chromium films in solution. In this case, the stress and impedance data agreed very well, expressing a decreasing trend (Report #2, Figs. 4 and 6).

Figure 8 - Summary of the data from Fig. 1 (black lines) and Fig. 6 (blue lines).
